Flood Control Project Maintenance
2009 Structure Summary Report
Overall Unit and Item Ratings

Reclamation District No. 2063 Crows Landing

Reclamation District No. 2063 Pumping Plant (Nelson Drain)

Pumping Plant Rating	M
Date of Inspection	7/28/2009
DWR Inspector	David Pesavento
Accompanied By	Joe Sallaberry RD 2063

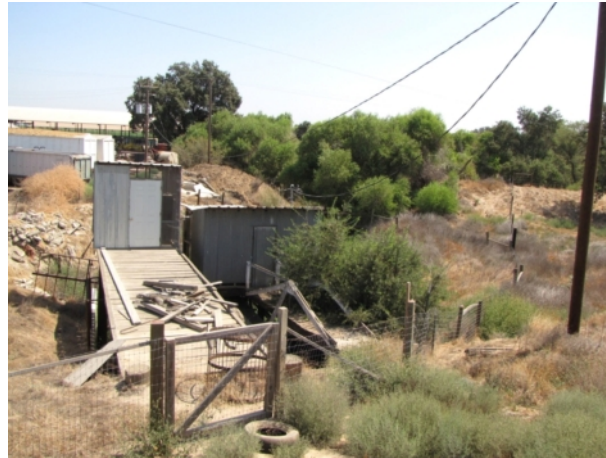
Levee Mile Report Line	3
Start Levee Mile	0.00
End Levee Mile	0.00
Location	
Category	Pump Stations
Item	Plant Building

View of the pump plant from the crown of the levee.

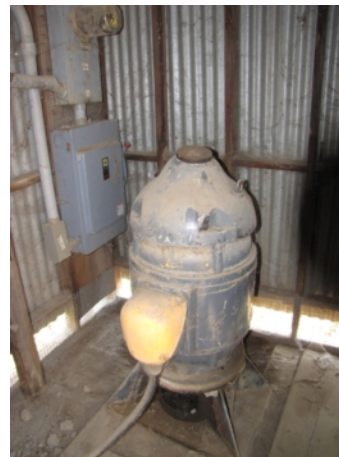
Levee Mile Report Line	7
Start Levee Mile	0.00
End Levee Mile	0.00
Location	
Category	Pump Stations
Item	Pumps

6	0.00	0.00	Pump Stations	Cranes		N	Inspector Comments: There is no crane at this plant.	°	°		6
7	0.00	0.00	Pump Stations	Pumps		M	Item inspected visually only. Item was not operated during the inspection. Inspector Comments: Several of the pumps have low oil levels. One pump does not have any oil. Oil needs to be added to the pumps and general maintenance needs to be done prior to the next flood season. The pumps were not turned on during this inspection.	°	°	Y	7
8	0.00	0.00	Pump Stations	Power		A	Item inspected visually only. Item was not operated during the inspection. Inspector Comments: The power supply is generally reliable. TID should do maintenance on the power riser above the plant building as noted above.	°	°		8
9	0.00	0.00	Pump Stations	Motors, Engines, Fans & Gear Reducers		N	Inspector Comments: There are no motors, electrical or mechanical equipment on this plant other than the pumps.	°	°		9

View of one of the pumps.

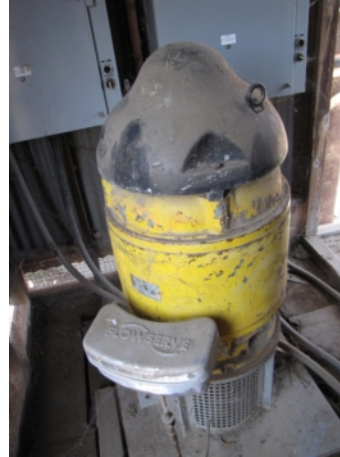
Levee Mile Report Line	7
Start Levee Mile	0.00
End Levee Mile	0.00
Location	
Category	Pump Stations
Item	Pumps
View of another pump. This pump's oil well was completely dry.	
dpesaven_20090820_80.jpg

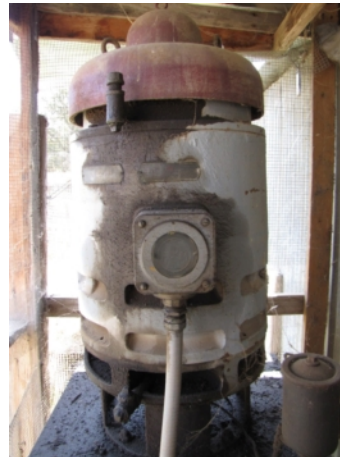
Levee Mile Report Line	7
Start Levee Mile	0.00
End Levee Mile	0.00
Location	
Category	Pump Stations
Item	Pumps
View of another pump.	
dpesaven_20090820_81.jpg

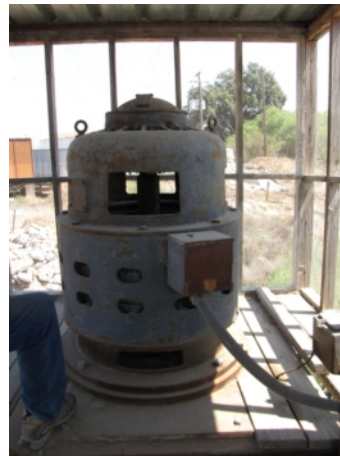
Levee Mile Report Line	7
Start Levee Mile	0.00
End Levee Mile	0.00
Location	
Category	Pump Stations
Item	Pumps
View of another pump.	
dpesaven_20090820_82.jpg

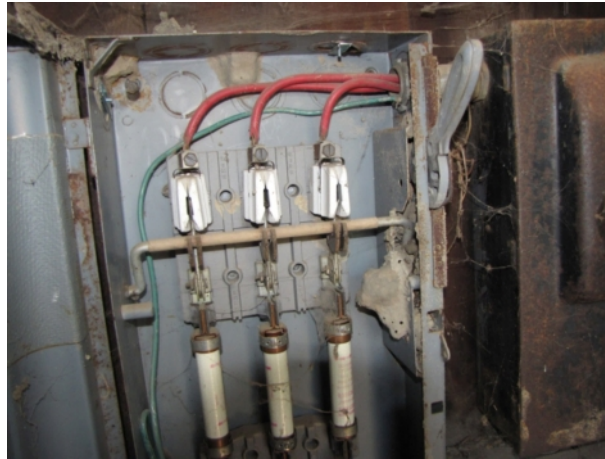
Levee Mile Report Line	10
Start Levee Mile	0.00
End Levee Mile	0.00
Location	
Category	Pump Stations
Item	Pump Control Systems

10	0.00	0.00	Pump Stations	Pump Control Systems		M	Inspector Comments: General maintenance should be done on the circuit breakers to make sure they are clean and functional. Wasps have built nests in several of the electrical boxes that need to be cleaned out.	°	°	Y	10

View of one of the circuit breakers.

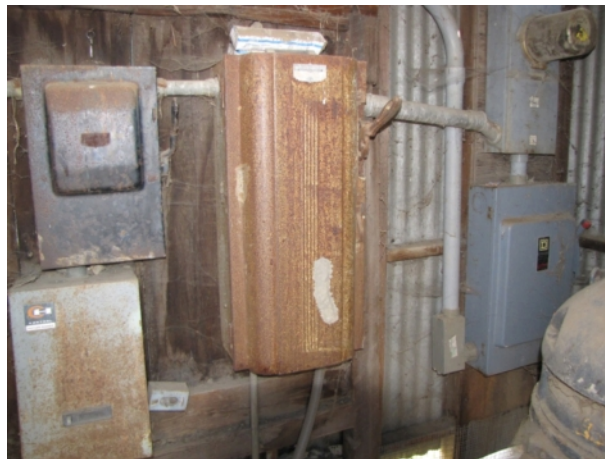
Levee Mile Report Line	10
Start Levee Mile	0.00
End Levee Mile	0.00
Location	
Category	Pump Stations
Item	Pump Control Systems

View of several of the circuit breaker boxes and meter.

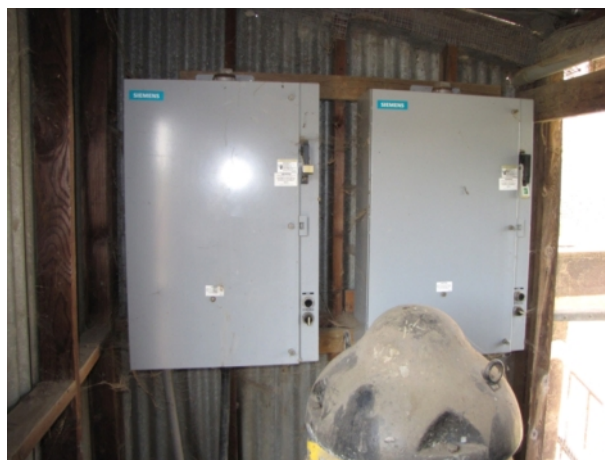
Levee Mile Report Line	10
Start Levee Mile	0.00
End Levee Mile	0.00
Location	
Category	Pump Stations
Item	Pump Control Systems

View of the pump control boxes. These have been recently installed.

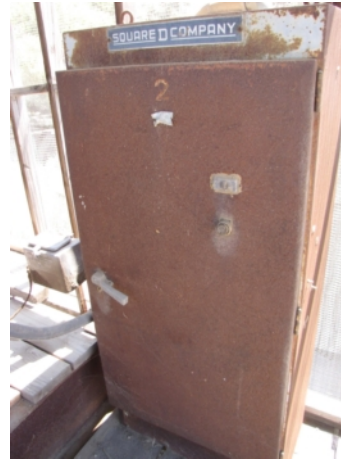
Levee Mile Report Line	10
Start Levee Mile	0.00
End Levee Mile	0.00
Location	
Category	Pump Stations
Item	Pump Control Systems

View of another control box.

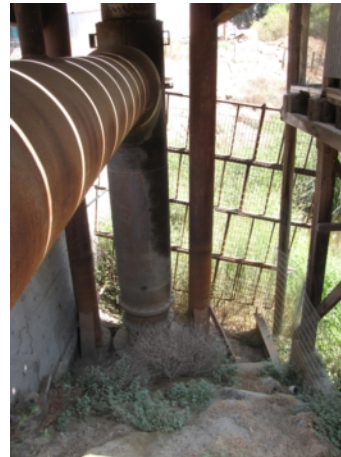
Levee Mile Report Line	11
Start Levee Mile	0.00
End Levee Mile	0.00
Location	
Category	Pump Stations
Item	Sumps/Wet Well

LMR No.	Levee Mile		Category	Item	Location	Rating	Action/Comment	GPS Latitude/Longitude		Photo	Issue No.
	Start	End						Start	End		
11	0.00	0.00	Pump Stations	Sumps/Wet Well		A	Inspector Comments: The pumps will function and the sumps are generally free of debris, but vegetation is starting to accumulate and will need to be cleared in the near future.	°	°	Y	11
12	0.00	0.00	Pump Stations	Trash Racks		A	Inspector Comments: The trash racks appear to be adequately maintained and free of debris.	°	°	Y	12
13	0.00	0.00	Pump Stations	Trash Rakes		N	Inspector Comments: The trash racks are manually cleared.	°	°		13
14	0.00	0.00	Pump Stations	Sluice / Slide Gates		A	Inspector Comments: The gate on the low flow pipe was not visible due to insect activity in the riser, but the district stated that the gate is stainless steel and will not corrode for many years. The gate moved easily.	°	°		14
15	0.00	0.00	Pump Stations	Electric Gate Operators		N	Inspector Comments: The slide gate is only manually operated.	°	°		15

View of one of the sumps.

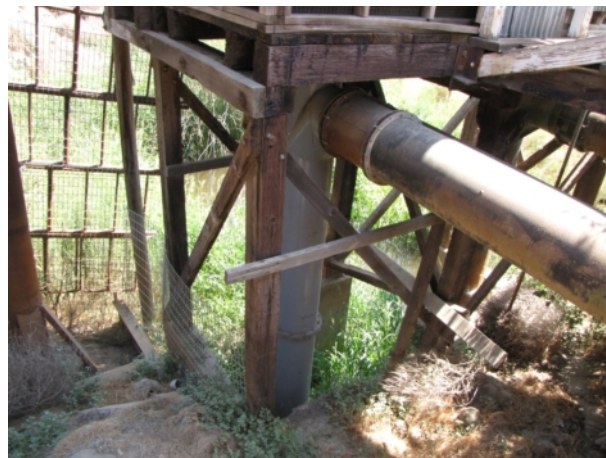
Levee Mile Report Line	11
Start Levee Mile	0.00
End Levee Mile	0.00
Location	
Category	Pump Stations
Item	Sumps/Wet Well

View of the other sump.

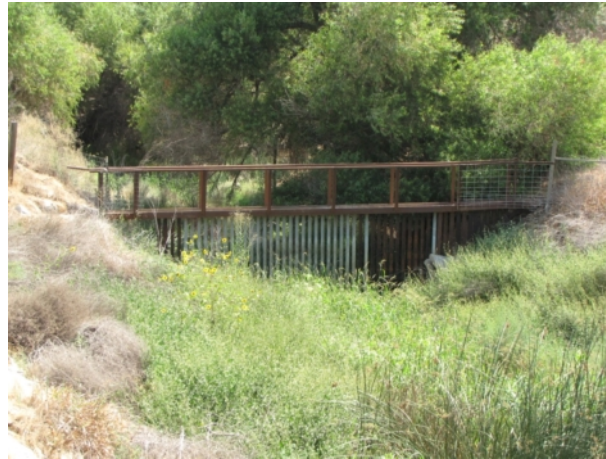
Levee Mile Report Line	12
Start Levee Mile	0.00
End Levee Mile	0.00
Location	
Category	Pump Stations
Item	Trash Racks

View of the trash rack.

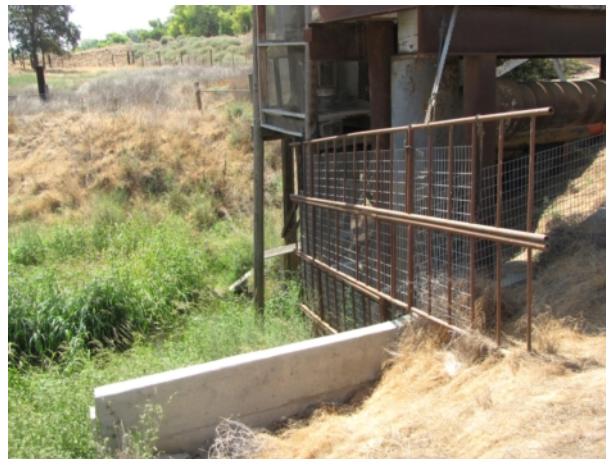
Levee Mile Report Line	12
Start Levee Mile	0.00
End Levee Mile	0.00
Location	
Category	Pump Stations
Item	Trash Racks

View of the trash rack immediately in front of the pump intakes.

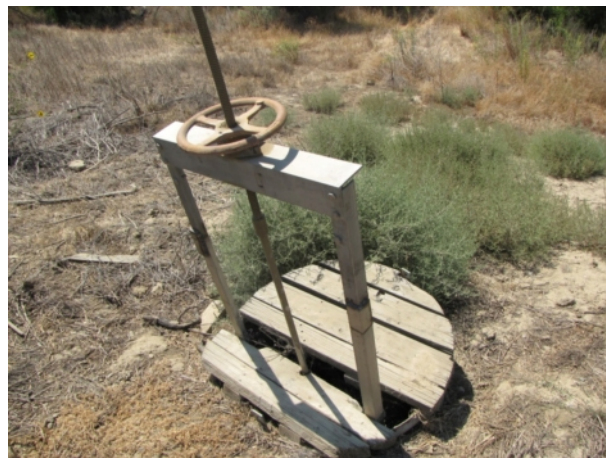
Levee Mile Report Line	16
Start Levee Mile	0.00
End Levee Mile	0.00
Location	
Category	Pump Stations
Item	Manual Gate Operators

16	0.00	0.00	Pump Stations	Manual Gate Operators		A	Inspector Comments: The operator turned easily and appeared to be well maintained.	°	°	Y	16
17	0.00	0.00	Pump Stations	Other Metallic Items		A	Inspector Comments: There is some rust on the metal support structure that does not appear to threaten the structural integrity of the plant.	°	°		17
18	0.00	0.00	Pump Stations	Flap Gates		U	Inspector Comments: There are no flap gates on this structure. The low flow channel is manually closed and the pressure pipes have vents preventing them from carrying a flow toward when the pumps are not working. Repair holes in the low flow pipe & add a flap gate.	°	°	Y	18
19	0.00	0.00	Pump Stations	Closure Structures		N	Inspector Comments: There are no closure structures at this plant.	°	°		19
20	0.00	0.00	Pump Stations	Security Fencing		A	Inspector Comments: There is a low fence around the station, but it is not vandalized and does not appear to have an problem with unauthorized personnel accessing it.	°	°		20

View of the gate operator for the low flow channel.

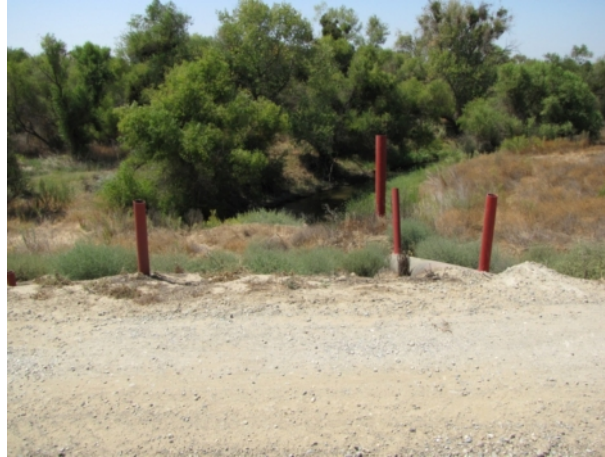
Levee Mile Report Line	18
Start Levee Mile	0.00
End Levee Mile	0.00
Location	
Category	Pump Stations
Item	Flap Gates
View of the vent risers on the discharge pipes.	
dpesaven_20090820_93.jpg

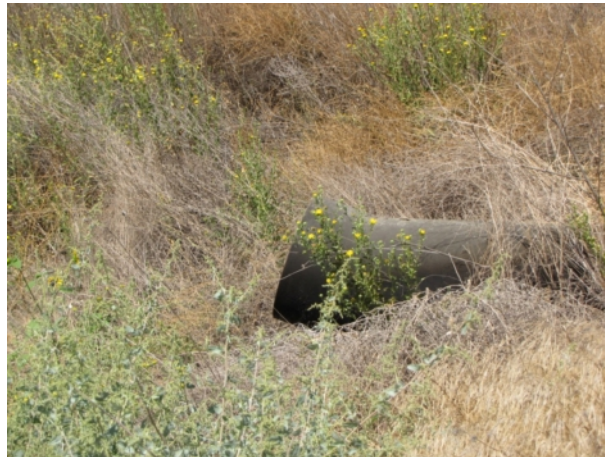
Levee Mile Report Line	18
Start Levee Mile	0.00
End Levee Mile	0.00
Location	
Category	Pump Stations
Item	Flap Gates
View of the discharge end of one of the pressure pipes.	
dpesaven_20090820_94.jpg

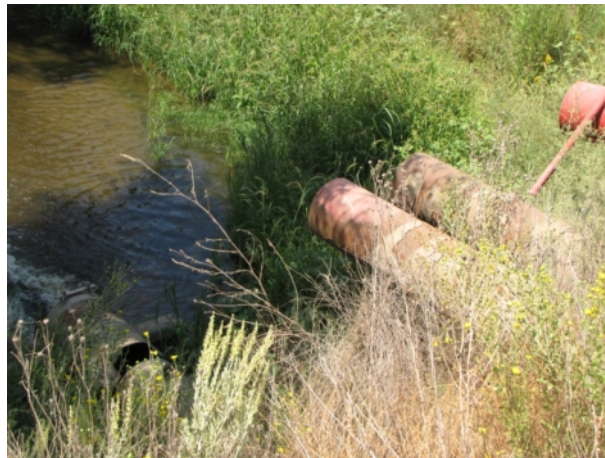
Levee Mile Report Line	18
Start Levee Mile	0.00
End Levee Mile	0.00
Location	
Category	Pump Stations
Item	Flap Gates
View of the other discharge ends of the pipes. Note the holes in the low flow pipe and the frame for a flap gate that is no longer there.	
dpesaven_20090820_95.jpg

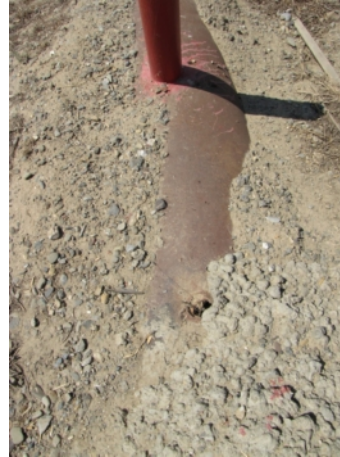
Levee Mile Report Line	21
Start Levee Mile	0.00
End Levee Mile	0.00
Location	
Category	Pump Stations
Item	Intake and Discharge Pipes

LMR No.	Levee Mile		Category	Item	* Location	** Rating	Action/Comment	GPS Latitude/Longitude		Photo	Issue No.
	Start	End						Start	End		
21	0.00	0.00	Pump Stations	Intake and Discharge Pipes		M	Inspector Comments: Most pipes appear to be in adequate condition. One of the risers above a vent on one pipe has been broken off and may allow water to flow out and erode the slope. A riser should be placed on the pipe at this location prior to the flood season.	° °		° °	Y 21
22	0.00	0.00	Pump Stations	Pressurized Pipe		A	Inspector Comments: With the exception of the missing riser noted above, the pipes appear to be in adequate condition. The pipes are scheduled for a fresh coat of paint soon.	° °		° °	22

View of the vent hole in the discharge pipe with a missing riser.
